CONCRETE CLOTH ARCHAEOLOGICAL SITE PROTECTIVE CAPS: A PRELIMINARY EVALUATION AT FORT WAINWRIGHT, DONNELLY TRAINING AREA, AK.

7/19/2016

Archaeological Site Capping Experiment on Fort Wainwright, Alaska

Concrete Cloth Archaeological Site Protective Caps: A Preliminary Evaluation Conducted at Fort Wainwright, Donnelly Training Area, Alaska

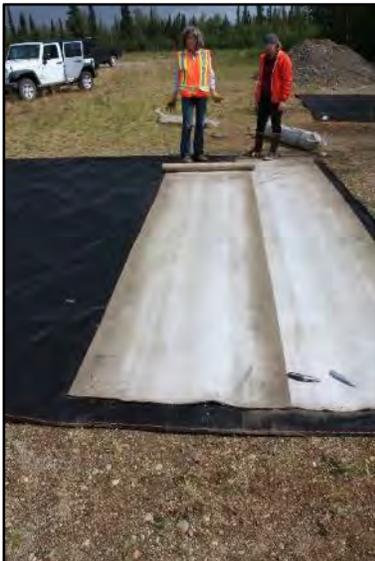
Figure 1. Deploying two rolls of concrete cloth and establishing a five inch overlap.

The installation process includes unfurling two rolls of the cloth at a time and overlapping the edge of one full length of concrete cloth five inches over the edge of the other full length of concrete cloth (Figure 1). Once the five inch overlap is set, the top strip of cloth is pulled back to allow enough room for applying two beads of clear, waterproof, polymer adhesive along the entire edge of the bottom section of concrete cloth. The polymer adhesive is applied using a standard caulk gun and tube (Figure 2). Once applied, the top strip of concrete cloth is pressed over the two beads of adhesive running the length of the bottom section of cloth. Walking along the seam helps to ensure a tight seal. Immediately after establishing a snug seal, 5/8 inch tapping screws are affixed along the top edge of cloth directly along the seam line. Screws are spaced approx. one foot apart (Figure 3). Once the concrete cloth is assembled, it is hydrated. The cloth can't be overwatered, but a standard for watering the material is using a water hose with a fan spray nozzle and spraying water approx. six (6) to eight (8) inches above the cloth in a circular motion for about 15 minutes (Figure 4). If time allows, repeat the process two more times, once per hour.

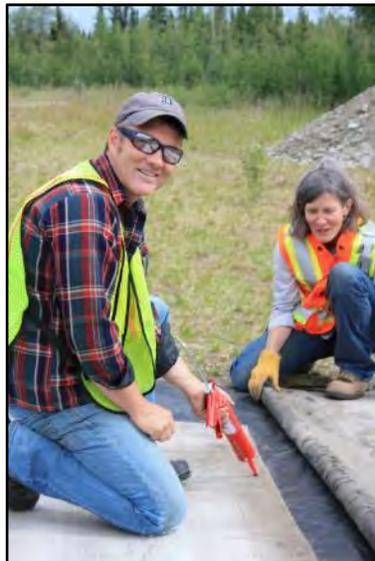
Figure 2. Earl McNabb and Lori Richter, SDSWCD, Applying two beads of polymer adhesive along the edge of the concrete cloth.

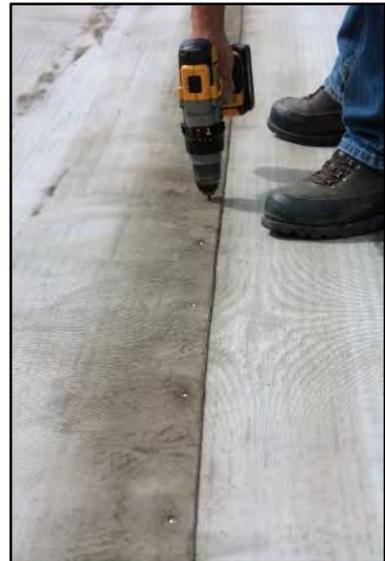
Figure 3. Screws affixed along the top edge of cloth directly along the seam line. Screws are spaced approx. one foot apart.

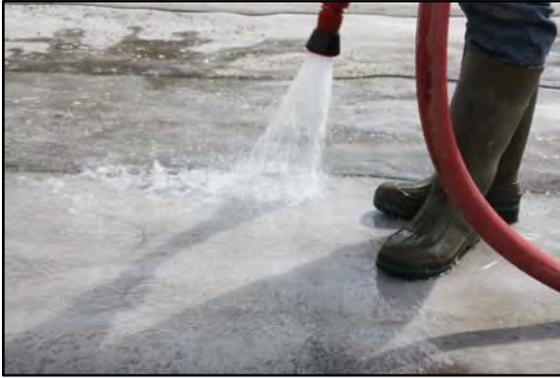
Figure 4. Hydrating concrete cloth with spray nozzle six to eight inches above the material in a circular motion

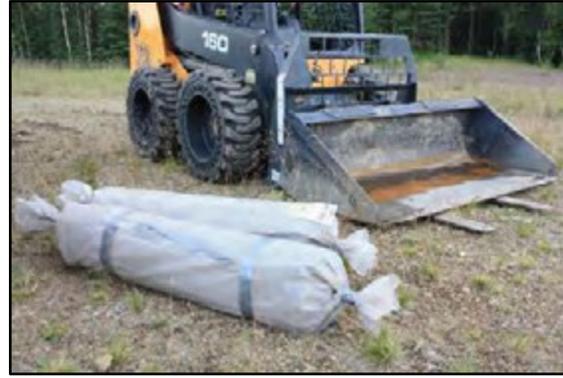
Figure 5. Two rolls of packaged concrete cloth weighing 150 lbs. each.

Considering vast amounts of DTA's archaeological sites are located in remote, access challenged, corners of Training Areas (TAs), it was determined that concrete cloth might be possible viable solution for capping hard to reach sites. Doing so would limit the need for large, gravel filled dump trucks to traverse uncertain terrain. Keeping with this determination, the lightest variety of the cloth, 3/16 inch, was tested. Each roll of concrete cloth weighs 150 lbs., which equates to a two person carry job (Figure 5). When fully deployed from the roll, the cloth length is 30 feet long and 3.5 feet wide.

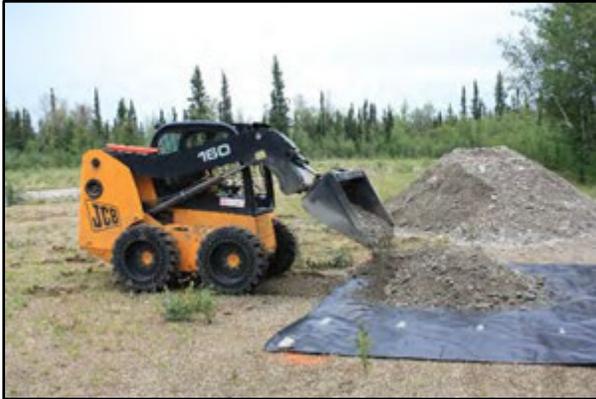
Figure 6. Applying 10 yards of gravel over faux artifacts and geotextile to establish a 4 to 6 inch gravel cap.

5 July 2016 Dr. Esdale, the SDSWCD, and TCM-Ranges/ITAM installed two test plots at Observation Point (OP) 7 in DTA East. One plot consisted of concrete cloth (3/16 inch thick) and the other 10 yards of pit-run gravel, applied four (4) to six (6) inches thick (Figures 6 and 7). The gravel test plot measured 15 feet X 15 feet and was underlain with geotextile fabric. The concrete cloth test plot measured 15 feet X 10 feet and was underlain with geotextile fabric. Replicated artifacts, obsidian tools and flakes, were situated beneath the geotextile at ground level for both plots. 26 total artifacts were used, 13 for the pit-run gravel plot and 13 for the concrete cloth plot. Replicated artifacts measured 1-4 cm² (Table 1). Each faux artifact was painted florescent orange. The orange paint was applied to distinguish the imitation artifacts from existing gravel deposits at OP 7 and to accentuate fracture lines that might occur in the artifacts resulting from the weight of the HMMWV (Figure 8). A HMMWV's wheel base is approximately 14 feet long and seven feet wide. 15 feet X 15 feet and 15 feet X 10 feet plot dimensions were chosen to ensure the total weight of the HMMWV was exerted on replicated artifacts for 10 passes over the pit-run material and 10 passes over the concrete cloth.

- Gravel purchased from local quarry and dumped at OP 7
- 15 feet X 15 feet plot dimensions measured on the ground and marked with florescent orange spray paint
- 13 Replicated artifacts measuring approx. 1-4 cm² painted florescent orange and placed within the measured plot dimensions
- 15 feet X 15 feet section of geotextile cut and placed over plot area and replicated artifacts
- Skid-Steer used to apply 10 yards of pit-run gravel four (4) to six (6) inches thick over the geotextile
- Skidsteer used to compact and smooth pit-run gravel application

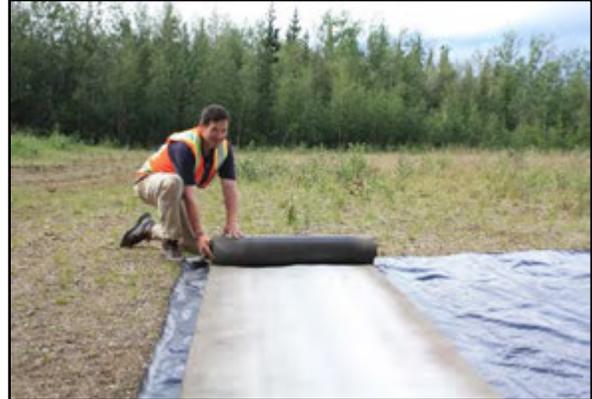
Figure 7. Chuck Burns, ITAM, Deploying concrete cloth over geotextile and replicated artifacts (prior to the hydration process.)

- 15 feet X 10 feet plot dimensions measured on the ground and marked with florescent orange spray paint
- 13 Replicated artifacts measuring approx. 1-4 cm² painted florescent orange and placed within the measured plot dimensions
- 15 feet X 10 feet section of geotextile cut and placed over plot area and replicated artifacts
- 15 feet X 10 feet of concrete cloth applied over the geotextile and then hydrated as described in the application process detailed in the “Concrete Cloth Overview” (Figure 9).

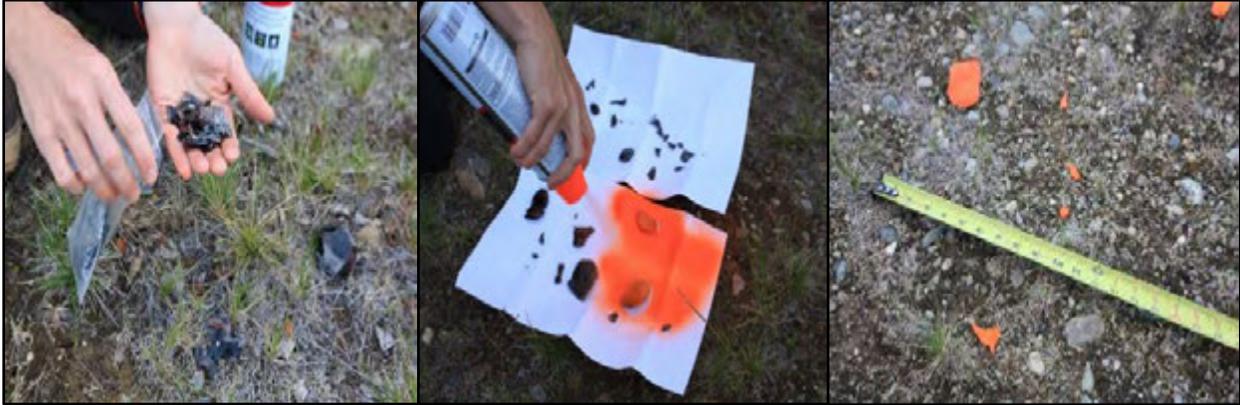
Figure 8. Replicated obsidian artifacts painted florescent orange and distributed over capping plots prior to material

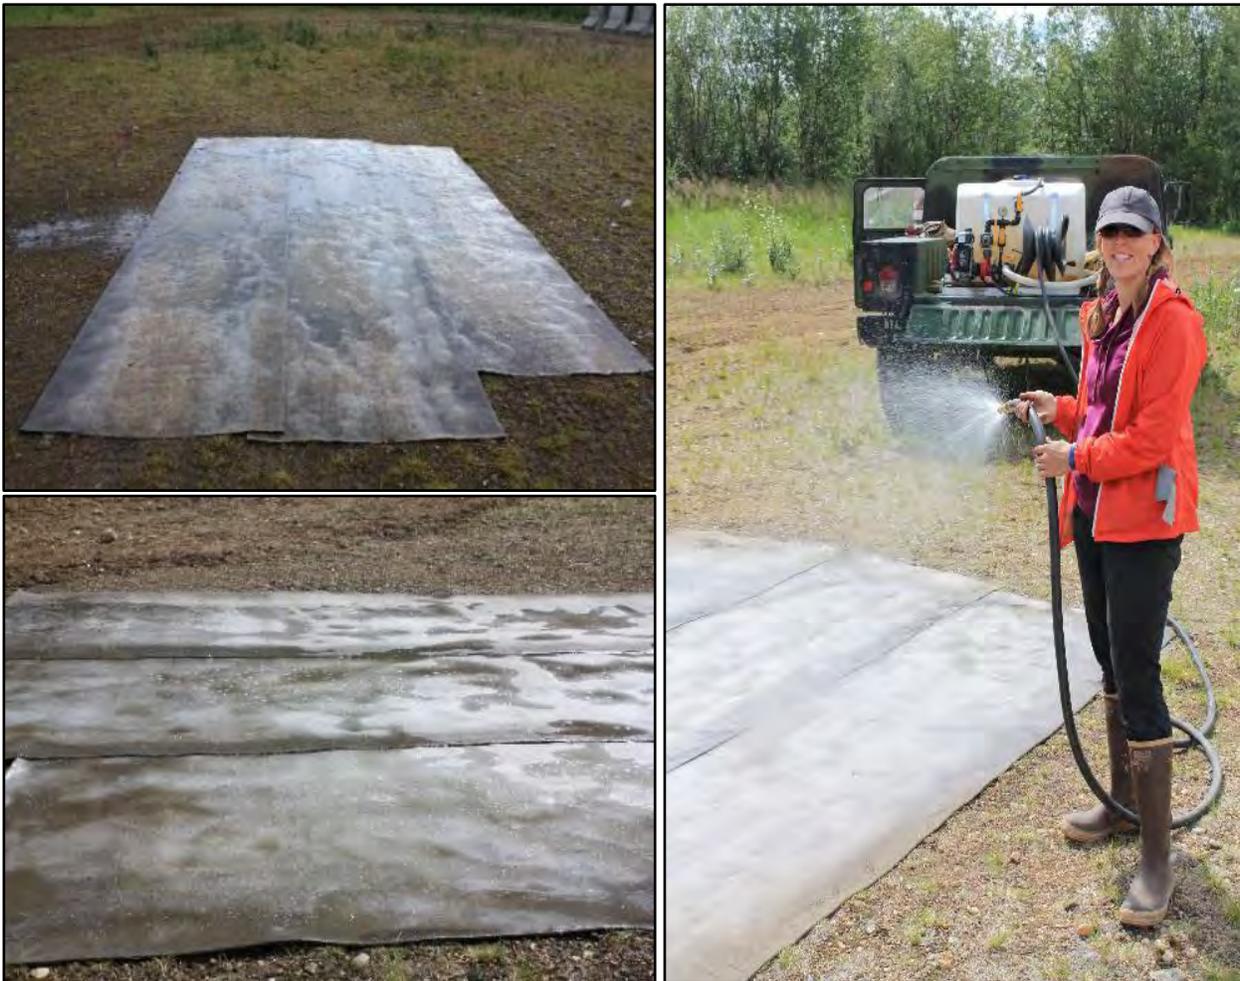
Figure 9. Hydrated concrete cloth; Dr. Julie Esdale hydrating the concrete cloth cap using a portable water tank and pump.

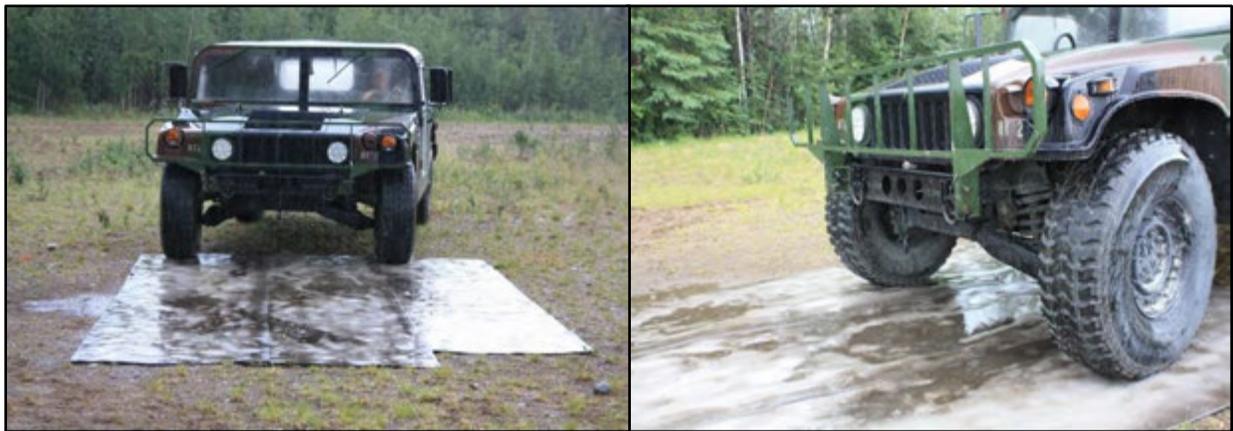
Figure 10. Simulated HMMWV movement/maneuver over the concrete cloth.

7 July 2016, after approx.48 hours of concrete cloth cure time, the two plots were tested against simulated HMMWV movement and maneuver. Following 10 HMMWV passes over each test plot, the pit-run gravel and the concrete cloth were removed to observe conditions of the replicated artifacts (Figures 10-13). (HMMWV weight approx. 5,000 lbs.)

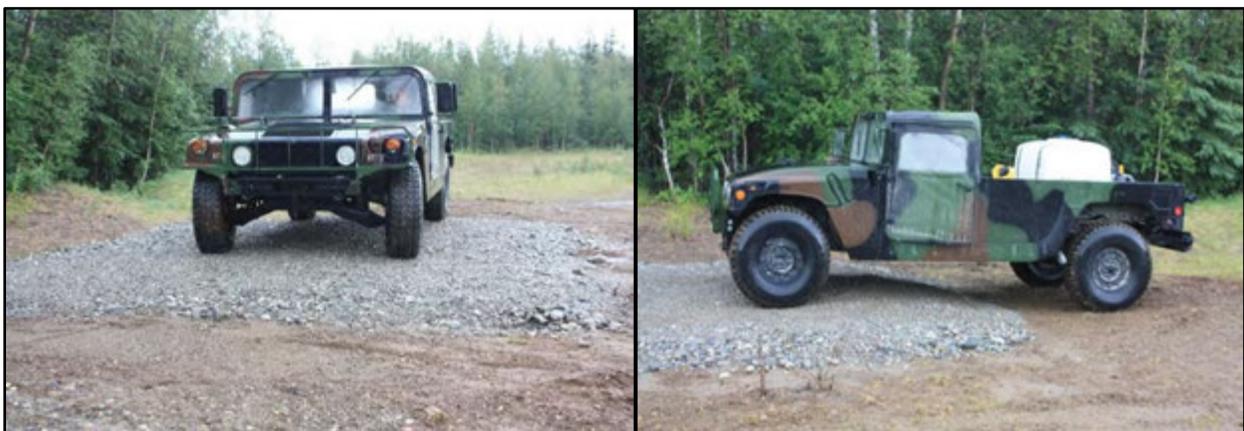
Figure 11. Simulated HMMWV movement/maneuver over the gravel (pit-run) cap

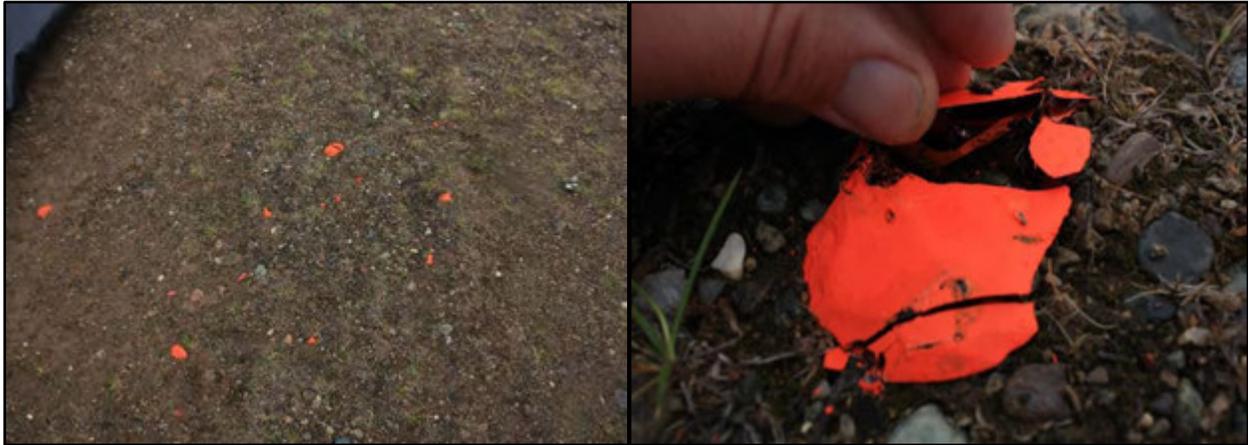
Figure 13. Replicated artifacts following simulated HMMWV movement/maneuver over the gravel cap. 4 out of 13 surface artifacts were fractured.

- After 10 passes, four (4) of 13 replicated artifacts were fractured.
- No damage to the gravel cap was observed.

This test was qualitative and based entirely on in-field observation. Applying and removing the concrete cloth by hand was a gentle process. Conversely, applying and removing the pit-run gravel with a skidsteer was considerably more invasive. The ratio of fractured to non-fractured artifacts for the concrete cloth test plot points largely to the crushing weight of the HMMWV (approx. 5,000 lbs.) passing over an only 3/16 inch protective barrier. The four (4) to six (6) pit-run gravel test plot provided much better protection to the replicated artifacts placed at ground level. The ratio of fractured to non-fractured artifacts for the pit-run gravel test plot can likely be attributed to the aggressive gravel application and removal process.

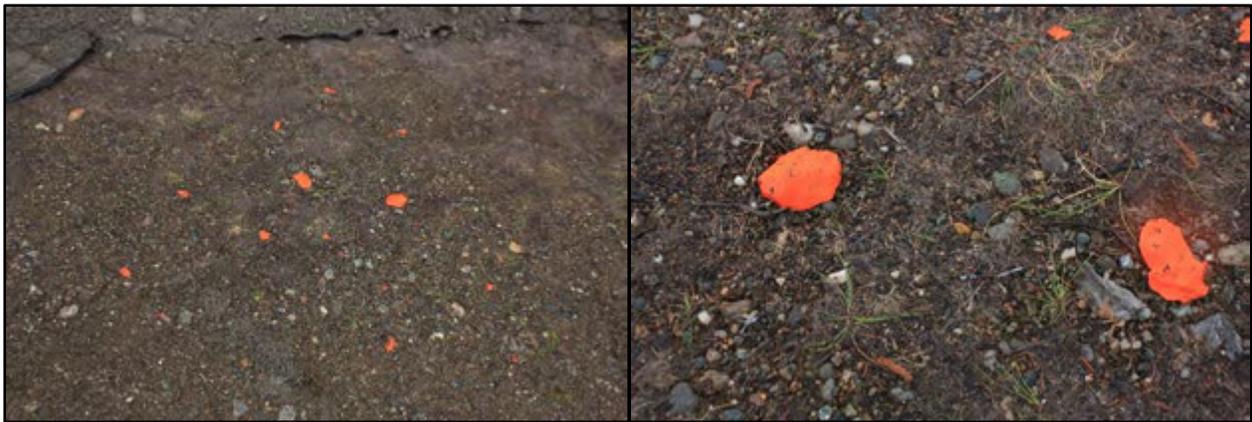
Figure 12. Replicated artifacts following simulated HMMWV movement/maneuver over the concrete cloth cap. 9 out of 13 surface artifacts were fractured.

- After 10 passes, nine (9) of the 13 replicated artifacts were fractured.
- No damage to the concrete was observed.

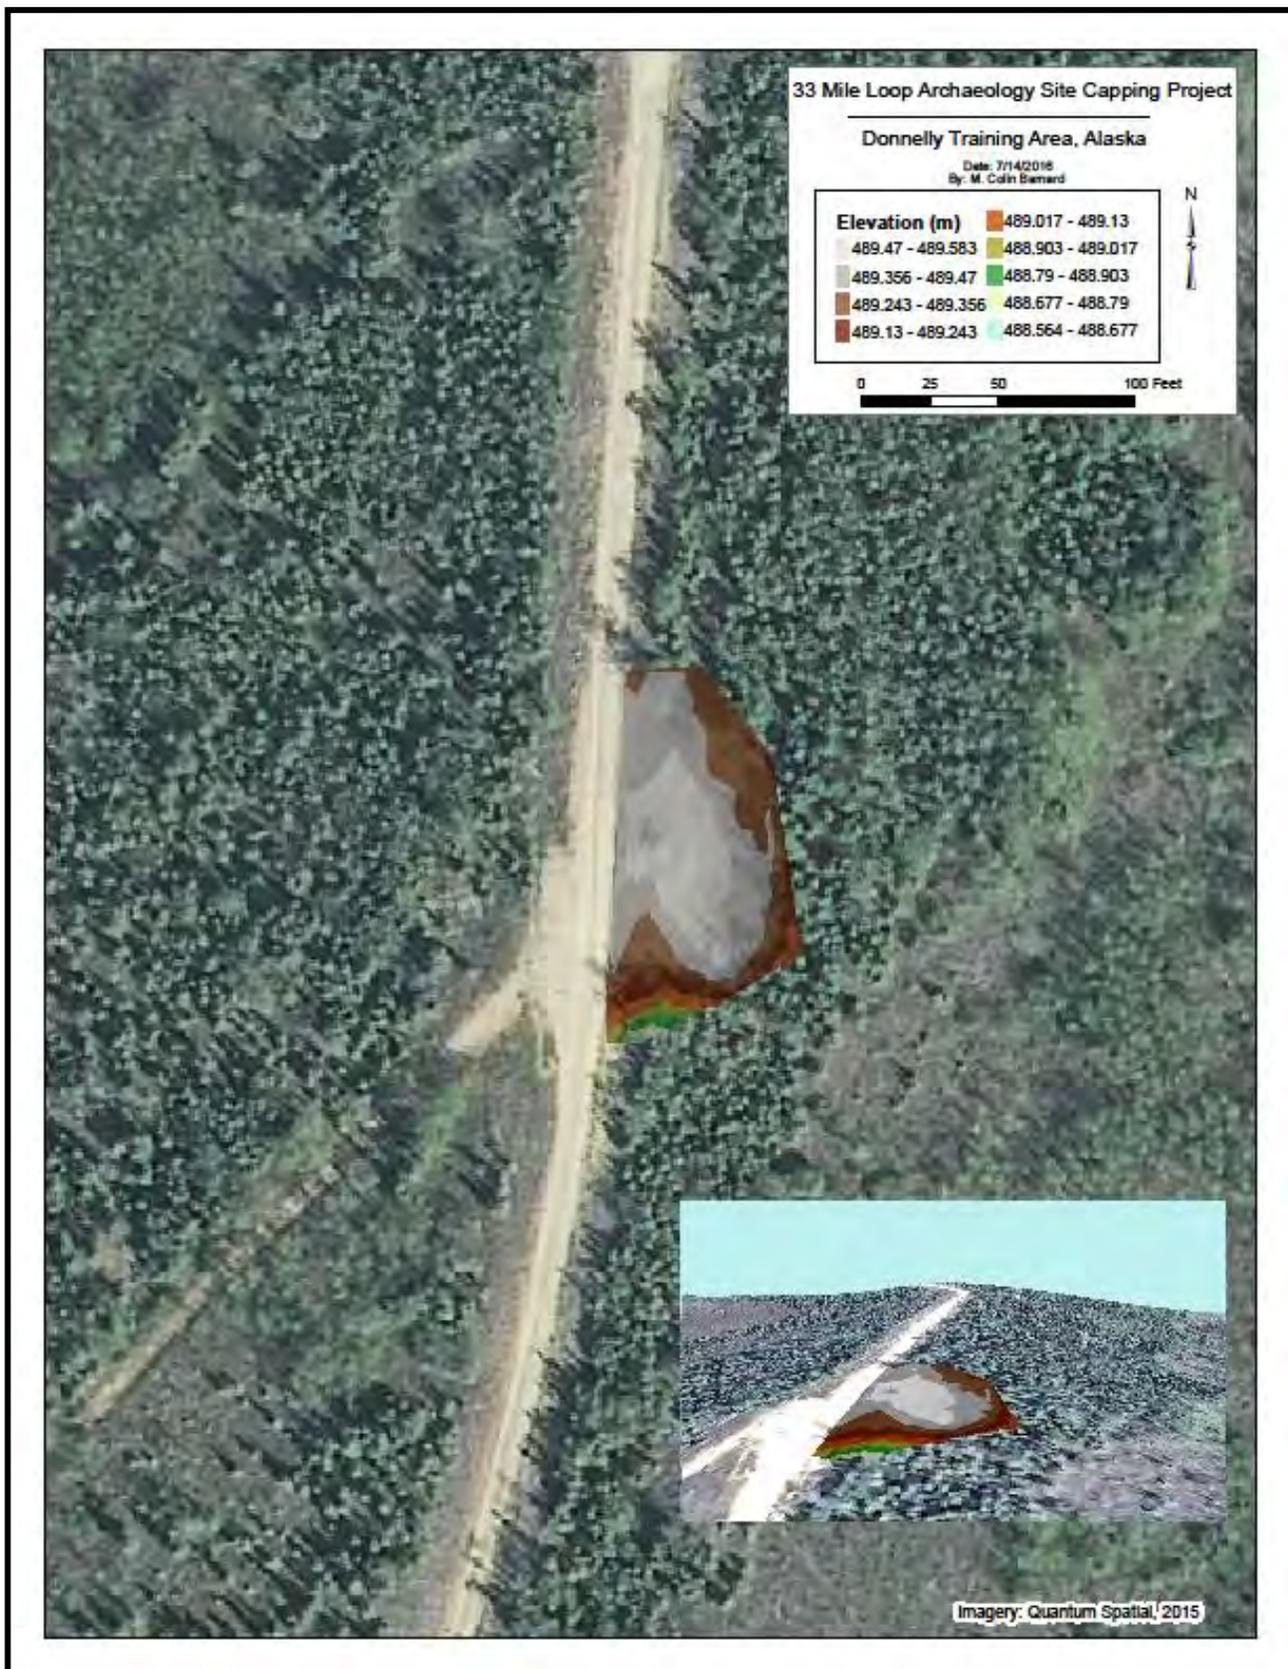
Figure 15. 33 Mile Loop Site Capping Project Survey Grade GPS. (Map prepared by Colin Barnard, SDSWCD.)

Test 2 will assess protective qualities for both a traditional gravel cap and a concrete cloth cap. The two caps are adjacent to one another. Site assessments will entail monitoring and recording effects from wheeled movement and maneuver, both light (HMMWV) and heavy (Stryker), as well as, monitoring and recording changes, if any, to the capped site occurring due to natural erosion and wildfire. Timeframe for monitoring efforts is not yet specified, but will be better determined following the 22 July Arctic Anvil training event. Long-term monitoring will be conducted by Dr. Esdale, her team of archaeologists, and agronomists and engineers from the SDSWCD. Prior to prepping the site for installing the two caps, SDSWCD recorded survey grade GPS points for the project area (Figure 15).

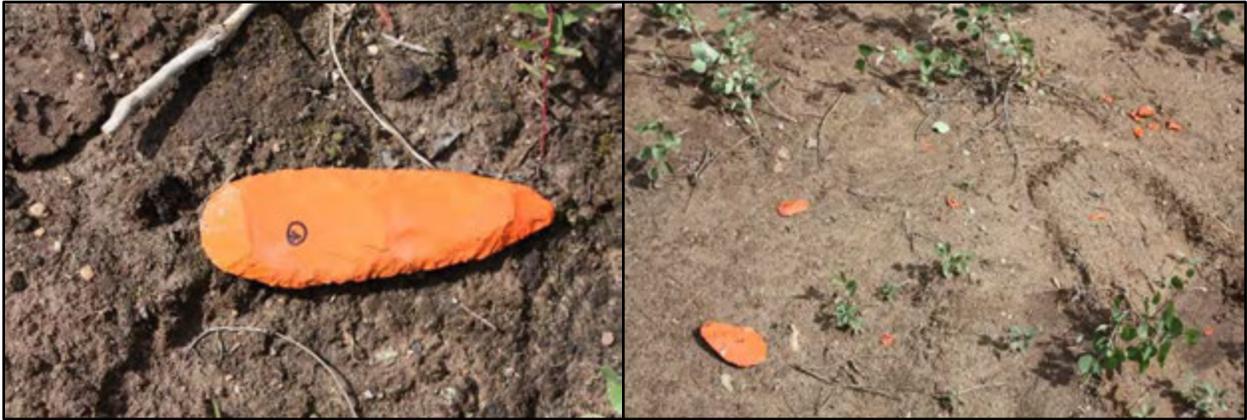
Figure 16. A total of 100 replicated artifacts were scattered atop the surface. 50 for the gravel capped portion of the site and 50 for the concrete cloth portion of the site.

5 July 2016, following SDSWCD initial topographic survey, Dr. Esdale, her team, and TCM-Ranges prepared Site XMH-891 for long term site cap monitoring. Site preparation included creating a replicated, surface level, lithic scatter for the portion of the site to be capped with gravel and the portion of the site to be capped with concrete cloth. Each replicated lithic scatter was comprised of tools and flake debris fashioned from obsidian. Just as in Test 1, each imitation artifact was painted florescent orange to be easily distinguishable from existing gravel deposits and to emphasize fracture lines that might occur due to vehicular movement and maneuver. A total of 100 replicated artifacts were scattered atop the surface. 50 for the gravel capped portion of the site and 50 for the concrete cloth portion of the site. Each scatter measured approx. five meters by five meters (Figure 16). Artifacts ranged in size from large bifaces (up to 16 cm long) to small re-sharpening flakes (<1 cm²) (Table 1). Once each faux artifact was in place, Fort Wainwright archaeology (CSU-CEMML) recorded fixed points for all 100 artifacts using a Sokkia Set600 total station (Figure 17).

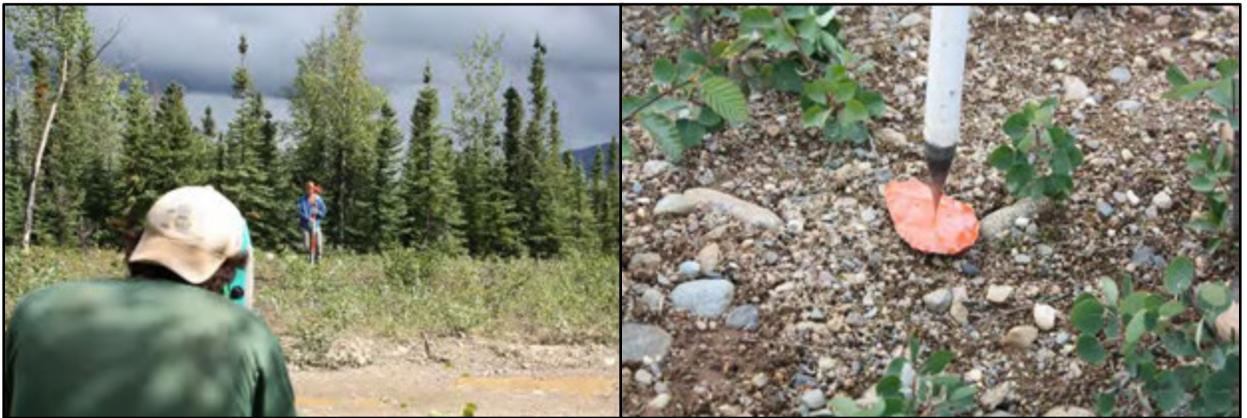
Figure 17. The Wainwright/DTA archaeology team (CSU-CEMML) recording fixed points for all 100 artifacts using Sokkia Set600 total station.

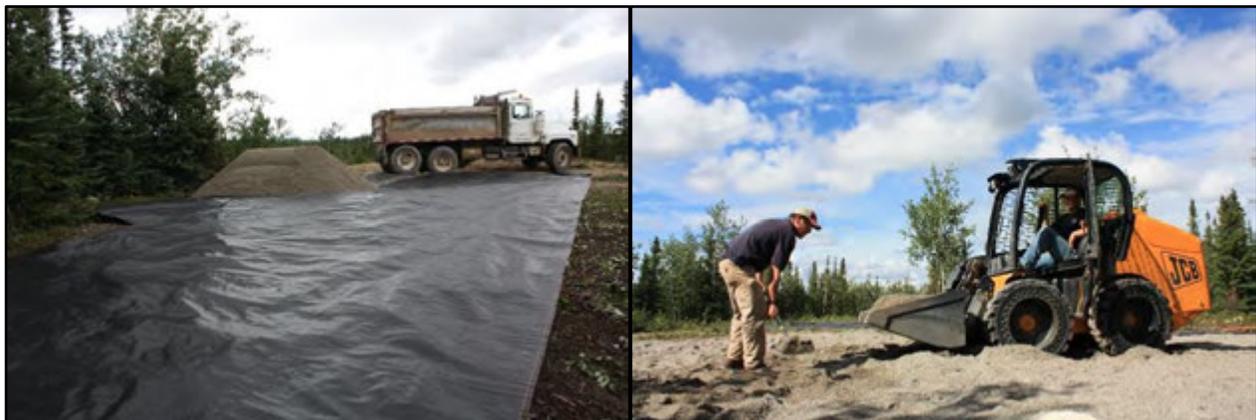
Figure 18. Prior to placing the concrete cloth over the geotextile, sand was delivered to the site and a thin layer was spread by hand and skidsteer to create a level surface. SDSWCD's Earl McNabb relaxes while overseeing shovel work performed by Chuck Burns, TCM-Ranges/ITAM.

6-7 July the SDSWCD, Wainwright Archeology, and TCM-Ranges, capped Site XMH-891. Geotextile was placed over the replicated artifacts and atop the entire site cap parameter. Following the geotextile application, gravel, delivered by dump truck, was spread six (6) to eight (8) inches over the northern two-thirds of the capping parameter. A skidsteer was used to spread, smooth, and compact the gravel. Simultaneously, 3/16 inch thick concrete cloth was applied atop the faux artifacts and geotextile that covered approximately one-third of the capping parameter. Prior to placing the concrete cloth over the geotextile, a thin layer of sand was spread to create a level surface (Figure 18). The concrete cloth was

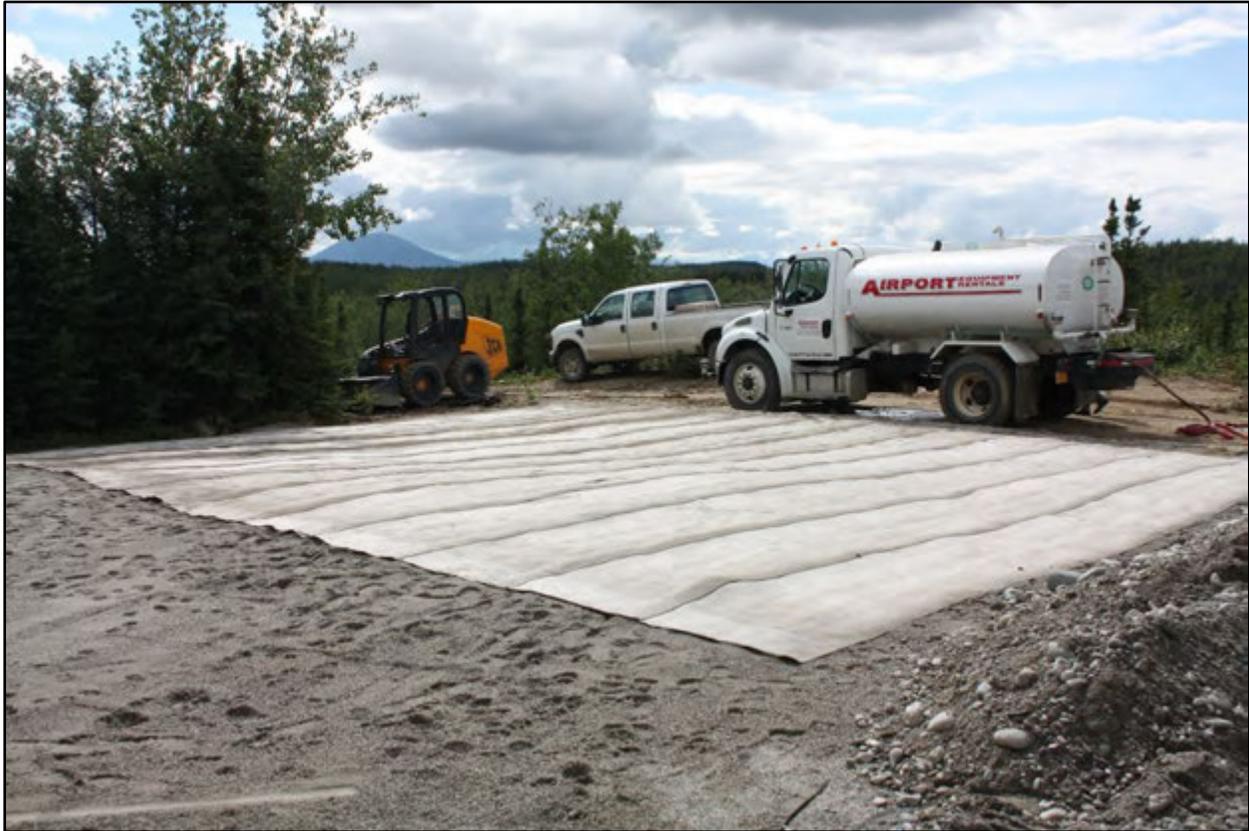
Figure 19. Concrete cloth installed prior to completing the hydration process. Cloth was hydrated using the featured water truck and attached hose.

installed as specified in the “Concrete Cloth Overview” and hydrated (Figure 19). Final site cap dimensions are as follows: 18 x 17 m area gravel pad and a 9.5 x 11 m concrete pad (Figure 20).

A single roll of 3/16 inch concrete cloth, 30 feet long and 3.5 feet wide, is \$672. The concrete cloth materials cost for capping an area similar to what is featured in Figures 19 and 20, is \$6,720 (10 rolls). The concrete cloth distributor nearest DTA is in Seattle, Washington. Costs associated with shipping 10 rolls of concrete cloth is approx. \$750. Total = \$7,470. Approximate surface area capped when considering the concrete cloth installation process requires a five-inch overlap per strip of cloth applied, is 30 feet X 30 feet.

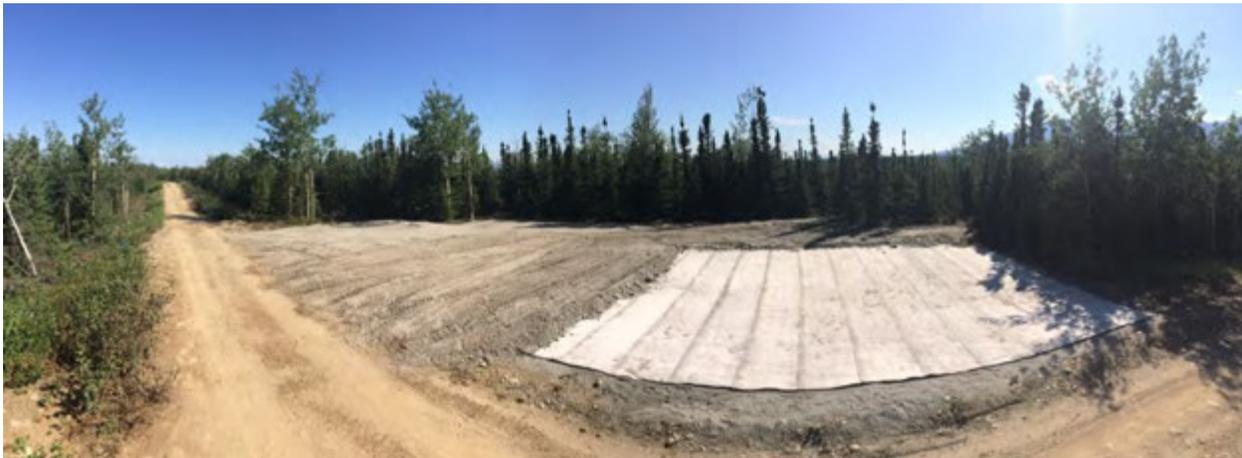
Figure 20. Gravel and concrete caps over XMH-891. This panorama photo projects a curve in the area of the concrete cloth. However, the cloth is parallel to the road and both are on a north-south axis. Cap dimensions: 18 x 17 m area gravel pad and a 9.5 x 11 m concrete pad.
